CAST IRON DOWNPIPE PIPE REPAIR CASE STUDY

Customer: Apartment Complex.

Site : London, UK.

System: 4" (100mm) cast Iron down pipes running from roof to ground level, rainwater.

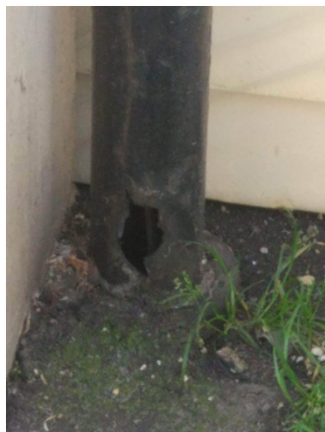
Cracks and corrosion have fractured the downpipes in this London apartment complex. Water ingress through the building is causing damage and structural issues throughout the building.

The inspection revealed many cracks, corrosion and blockages throughout the building.

The pipes were cleaned using specialist rotary tools, this removes scale build up and clears the pipe of debris and corrosion while also preparing the interior surface of the cast iron pipe to receive the coating.

25 metres of pipe in each run was then relined with our line in-situ system with minimum disruption.

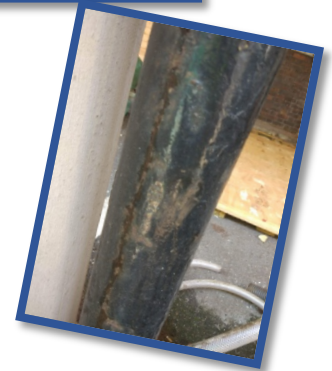
A final camera inspection revealed a successful repair and the system was pressure tested and re-commissioned.
