MARINE CASE STUDY

Vessel: Maersk Connector. 2016 Latest Generation Cable Layer. 10,000 Tons

System: HPU Cooling
water pipes.

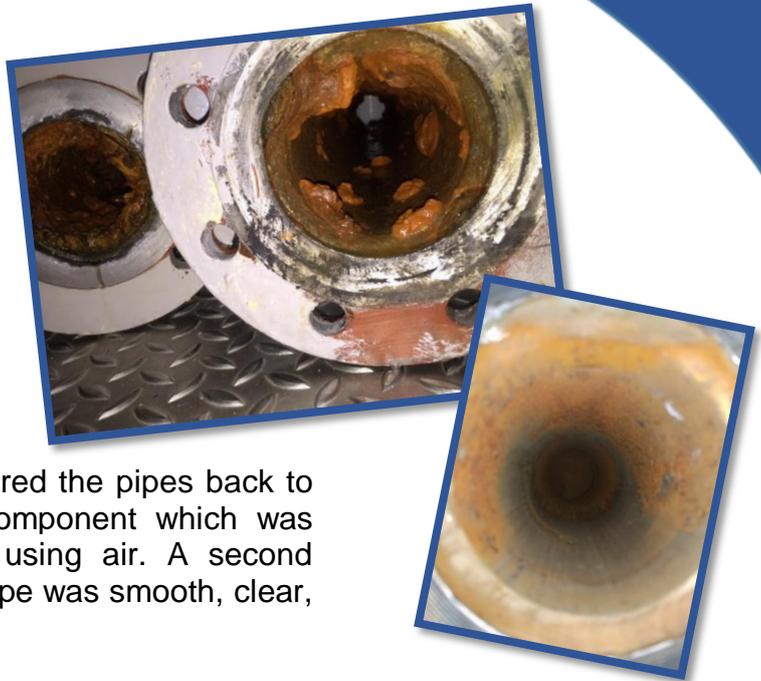
Problem: Cooling Pipes supplying the Hydraulic power unit was suffering from internal corrosion resulting in leaks and loss of performance. This vessel operates on a tight schedule, time for repair was limited.

Solution: R2 Pipetech's highly skilled technicians were able to solve this problem for the customer without causing any damage to the Ship. Firstly the team inspected the condition of the corroded pipes and assessed the nature of the problem. Borescope pictures revealed areas of the pipe with pitting and through-wall corrosion.

The R2 Pipetech team cleaned and restored the pipes back to their original state using an abrasive component which was shot-blasted through the entire system using air. A second inspection was conducted to ensure the pipe was smooth, clear, and ready for the liner to be installed.

R2 Pipetech's unique lining Epoxy was used to line the HPU Cooling system. The liquid Epoxy was blown through the system to evenly coat the walls of the pipes, forming a smooth barrier between the pipe and water. This barrier coating was then cured before final inspection confirmed that the system was restored to the highest standard of quality.
