## **PIPA Live Water Pipe Inspection and Cleaning Validation**

### **Scope of Works**

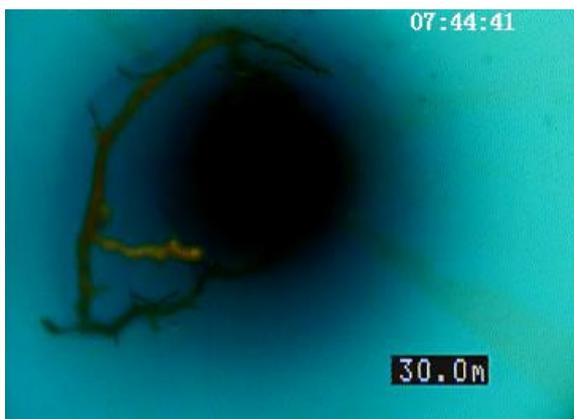
During the survey high levels of pipe debris was identified which in turn may have blocked pump filters creating the lack of water issues.

**Root ingress identified**

PIPA identified the internal pipe issues were created due to poor pipe installation services by the contractor. The pipeline should have been cleaned as part of the commissioning procedure.

PIPA offered to clean the pipeline using a double swab cleaning technique and also validated the results prior to pipe chlorination and recommissioning.

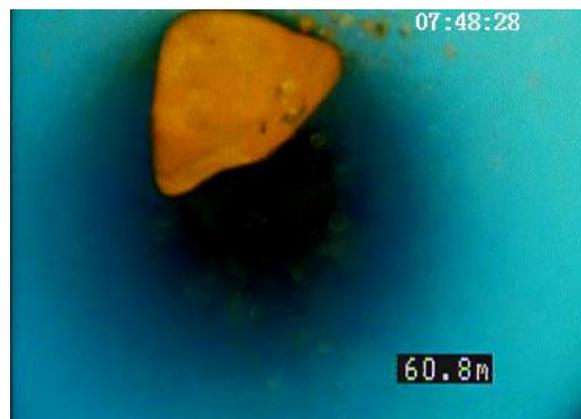
**Stones and debris in pipe**

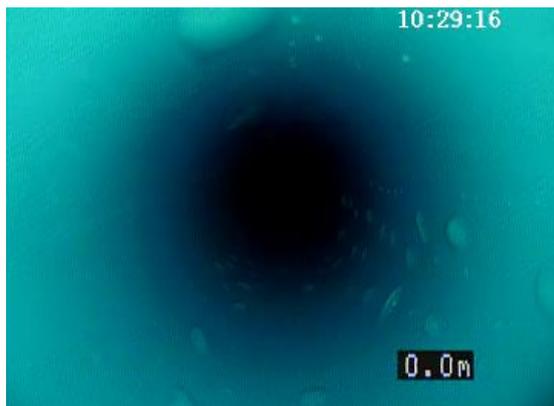
Cleaned pipe validation

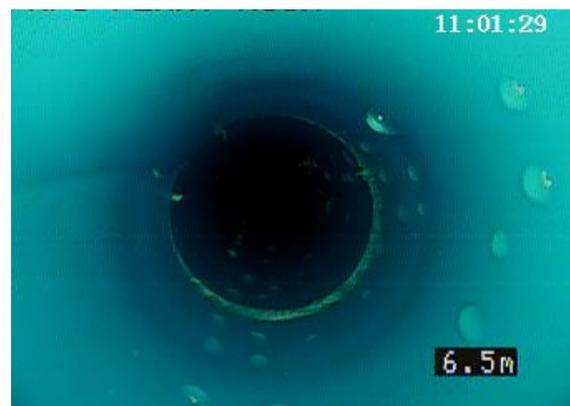
Cleaned pipe validation
