PIPA Hydro Scheme Pipe Inspection Case Study

PIPA recently undertook a live pipe inspection project in Scotland on 5.5 km of 400mm PVC/Ductile Iron hydro plant pipeline, due to a reduction in hydraulic output identified by the client.

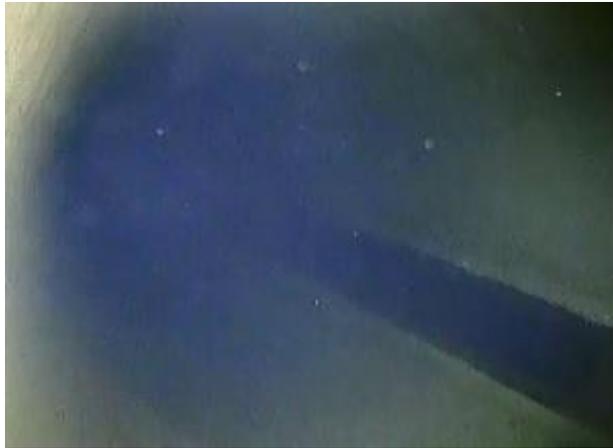
The entire 5.5 km of pipeline was successfully surveyed using the Pullycam™ and Pipepod™ products, with no leaks being identified; however air pockets were identified in 2 sections of pipeline, and also a 50 metre section of pipeline was successfully identified as being imploded due to terrain type and backfill.

Air Pockets Identified

The client installed 2 additional air release valves on the pipeline and exposed the imploded section identified during the live surveys (see images below).

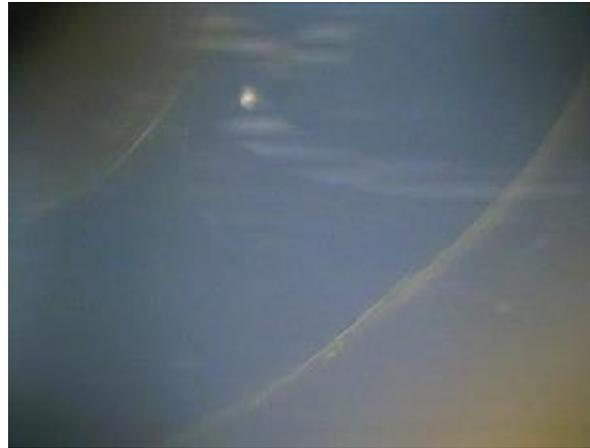
Pipe Implosion Identified

The necessary repairs were undertaken and the pipeline outputs have now returned to the original maximum output levels. The estimated cost of lost revenue due to the reduced hydraulic output is approximately £300 000 per annum.

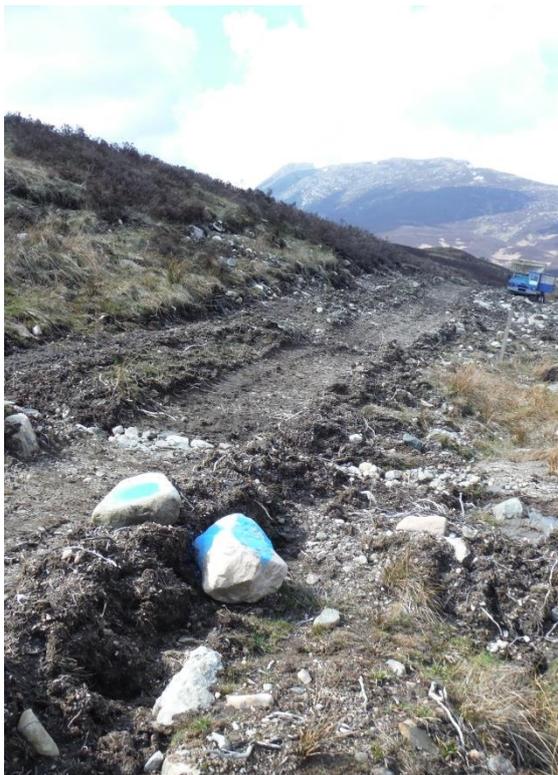
Sensor Traced Above Ground

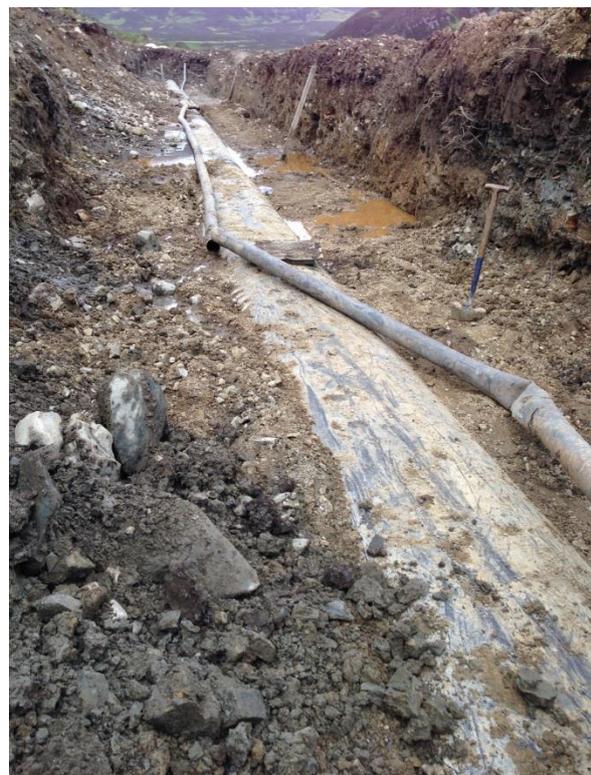
Exposed Imploded Pipeline
