PIPA Live Water Pipe Inspection and Leak Detection

Scope of Works

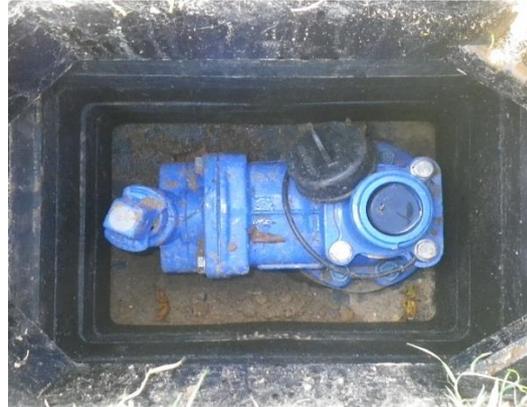
Hydrant (camera entry point)

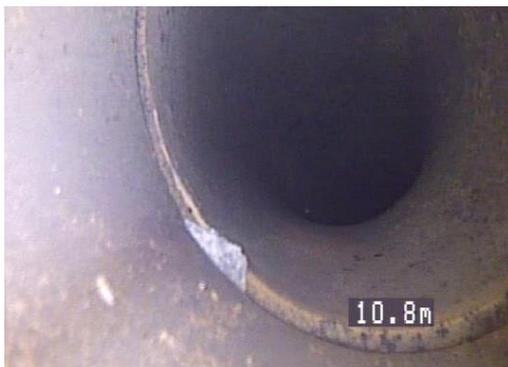
Leak identified on wide joint

- ◆ PIPA successfully identified the leak at 10.8 metres
- ◆ PIPA also identified an additional leak at 50 metres (all were later validated by client)
- ◆ A non-known in line valve was identified (see image above)
- ◆ Tethered insertion technology system allowed for precise identification of the leaks location
- ◆ Acoustic system is very responsive and operator was able to identify multiple leaks in close proximity to each other

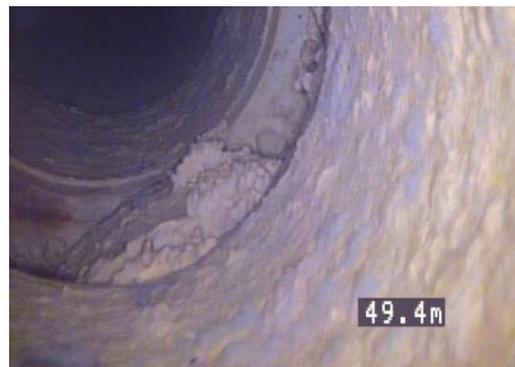
Buried valve identified
