CAST IRON DOWNPIPE PIPE REPAIR CASE STUDY

Customer: Apartment Complex.

Site : London, UK.

System: 4" (100mm) cast Iron down pipes running from roof to ground level, rainwater.

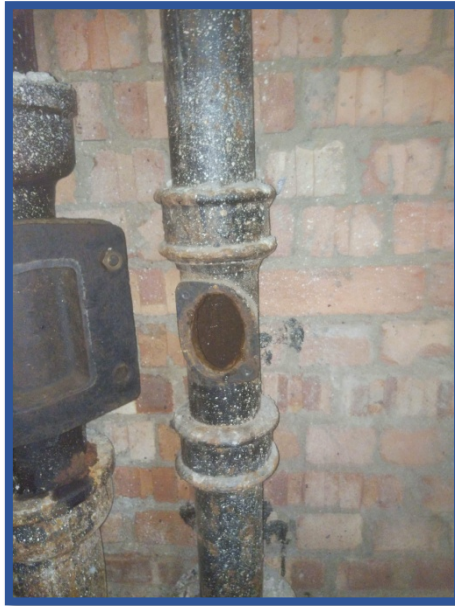
Cracks and corrosion have fractured the downpipes in this London apartment complex. Water ingress through the building is causing damage and structural issues throughout the building.

The inspection revealed many cracks, corrosion and blockages throughout the building.

The pipes were cleaned using specialist rotary tools, this removes scale build up and clears the pipe of debris and corrosion while also preparing the interior surface of the cast iron pipe to receive the coating.

25 metres of pipe in each run was then relined with our line in-situ system with minimum disruption.

A final camera inspection revealed a successful repair and the system was pressure tested and re-commissioned.
