MARINE CASE STUDY

Vessel: Maersk Connector. 2016 Latest Generation Cable Layer. 10,000 Tons

System: HPU Cooling
water pipes.

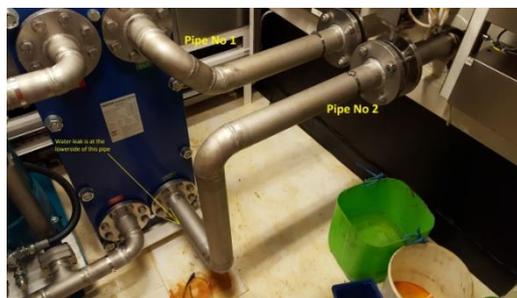
Problem: Cooling Pipes supplying the Hydraulic power unit was suffering from internal corrosion resulting in leaks and loss of performance. This vessel operates on a tight schedule, time for repair was limited.

Solution: R2 Pipetech's highly skilled technicians were able to solve this problem for the customer without causing any damage to the Ship. Firstly the team inspected the condition of the corroded pipes and assessed the nature of the problem. Borescope pictures revealed areas of the pipe with pitting and through-wall corrosion.

The R2 Pipetech team cleaned and restored the pipes back to their original state using an abrasive component which was shot-blasted through the entire system using air. A second inspection was conducted to ensure the pipe was smooth, clear, and ready for the liner to be installed.

R2 Pipetech's unique lining Epoxy was used to line the HPU Cooling system. The liquid Epoxy was blown through the system to evenly coat the walls of the pipes, forming a smooth barrier between the pipe and water. This barrier coating was then cured before final inspection confirmed that the system was restored to the highest standard of quality.

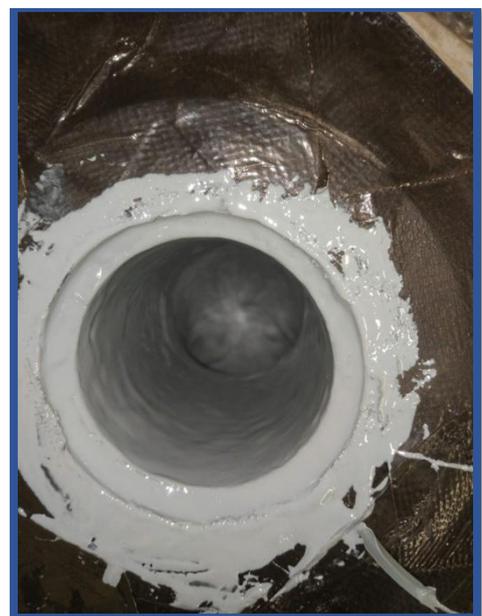
Furthermore, no interior or exterior damage or destruction was caused to the Ship during this time. This is the only small-diameter relining solution suitable for this application. The estimated life expectancy of the Epoxy is approximately 20 years. Recent inspection has revealed the coating is performing well, halting corrosion and pitting in the system.
