## **PIPA Live Water Pipe Inspection and Cleaning Validation**

### **Scope of Works**

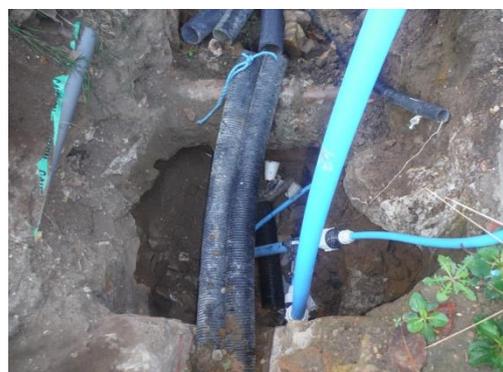
**Small diameter pipe (camera entry point)**

The client installed a T fitting for PIPA to undertake an internal pipe assessment.
