UNDERFLOOR PIPE REPAIR CASE STUDY

Site : Marine Testing Tank, Gosport, UK. One of the largest testing tanks in the world.

System: Under floor Pipes from Filtration plant room, 150mm (6") Diameter.
Cast Iron

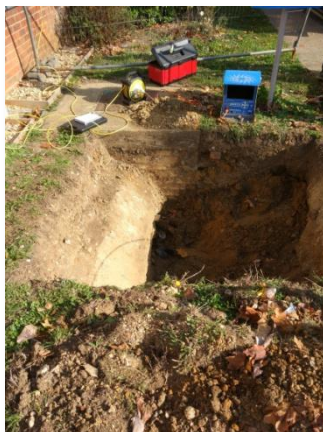
The Pipe supplying filtered water to a large tank was suspected to be leaking.

A full leak detection and camera survey revealed the leak to be directly under the tank, imbedded in 2 metres of concrete.

Solution: The pipe was opened at the nearest available location outside the building, this was 52 metres from the leaking point.

The pipe was then drained and cleaned using specialised rotary tools and a HP Jetter.

The Entire 160 metres of pipe was then relined with our inversion liner and epoxy resin and then cured.

A final pressure test and camera inspection revealed a successful repair, new valves were installed and the system was pressure tested and recommissioned

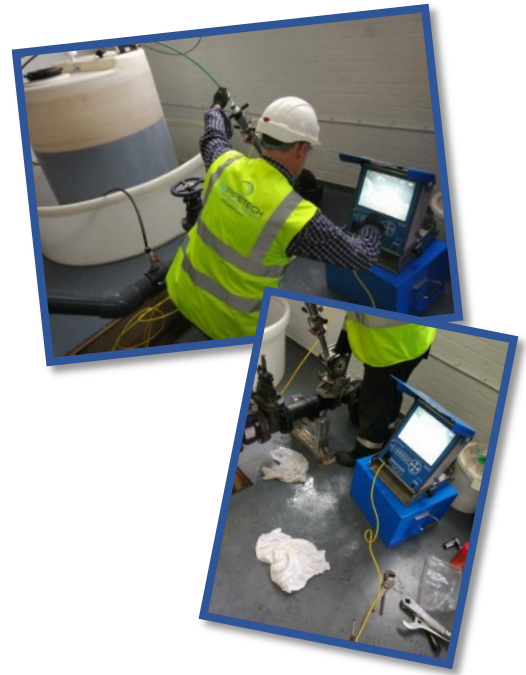
This pipe is returned to service and is now protected from any further deterioration of the host pipe.
